# Manhole Inspection Summary

Manhole # S41AA\_028MH

Insp Date: **8/20/08 8:30 AM**

**Location** Address: **n caroline st**

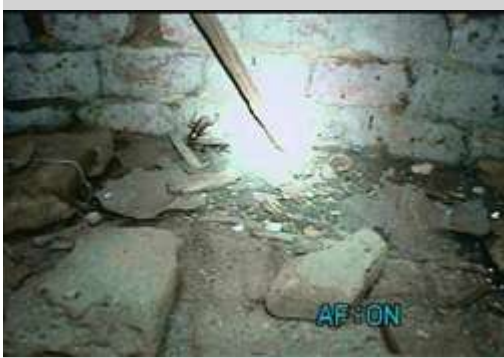
Defect 3

Condition: ☐ Sound ☐ Cracked ☐ Root Intrusion ☐ Deteriorated ☐ Leaks ☒ **Debris**

bench debris

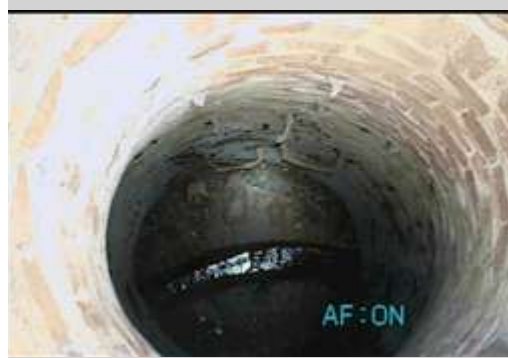
Defect 2

**Steps** Count: **5** Missing: **3** ☒ **Corroded**

missing/corroded steps

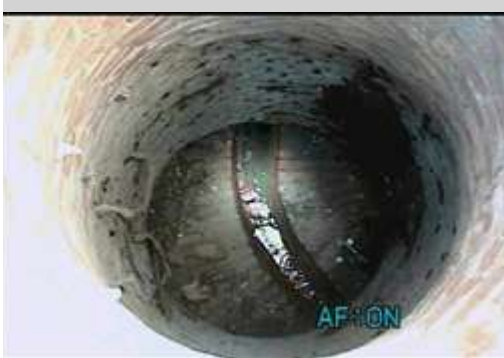
Defect 4

Infiltration: ☐ None ☐ Joint ☐ Cracks ☐ Mortar ☐ Roots ☒ **Wall**

Barrel Infiltration at wall

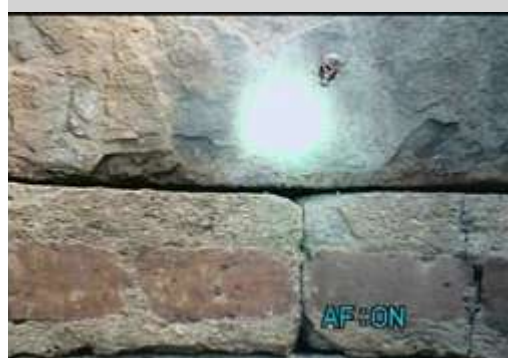
Defect 1

Condition: ☐ Sound ☒ **Cracked** ☐ Root Intrusion ☐ Loose Brick ☐ Deteriorated

chimney cracked, frame adj

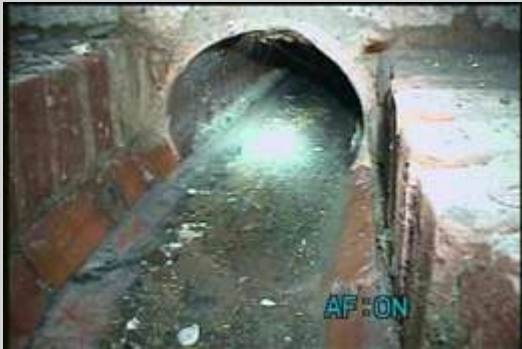
12 O'Clock Outflow

8 in. Circular Gravity Sewer  
Pipe Out @ 12 O'Clock

Invert Depth: **10.25** (ft.) Flow Characteristics: **Fast**

Infiltration: **None** Pipe Seal Cond: **Unknown**

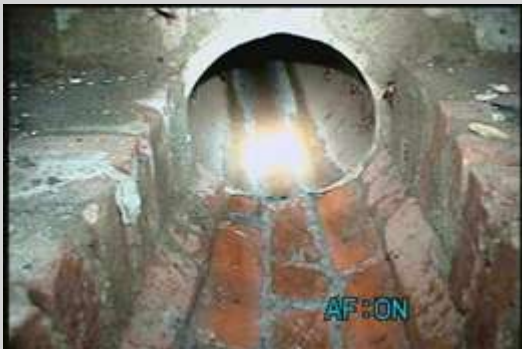
6 O'Clock Inflow

8 in. Circular Gravity Sewer  
Pipe In @ 5 O'Clock

Invert Depth: **10.20** (ft.) Flow Characteristics: **Fast**

Infiltration: **None** Pipe Seal Cond: **Unknown**
